RIVERWOOD - RESIDENTIAL HOME INSPECTION

1234 Main Street

04/30/2025 9:00AM

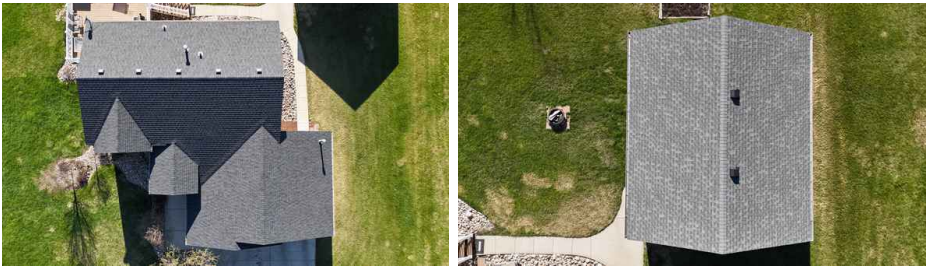
Roof Covering: Roof Was Inspected

Drone

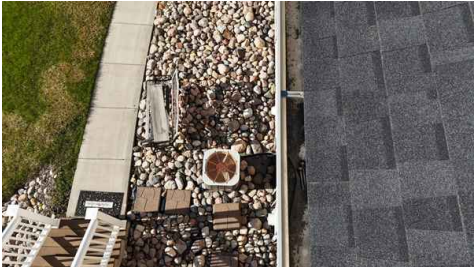
There were a couple bolts in the gutter. I recommend removing these to prevent more debris buildup in that specific area. This is not a major defect but can quickly become one if more material gets stuck on the bolts.

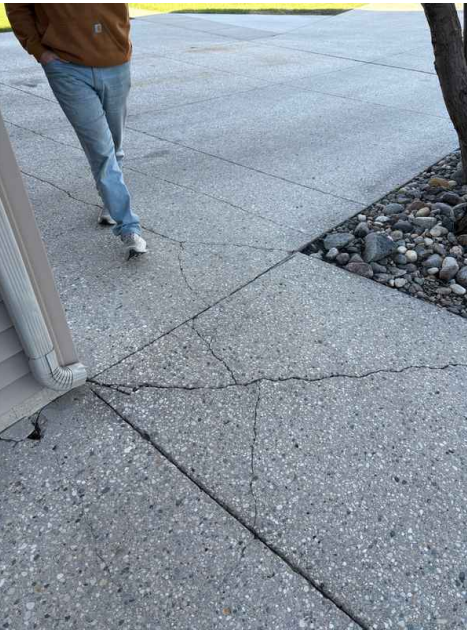
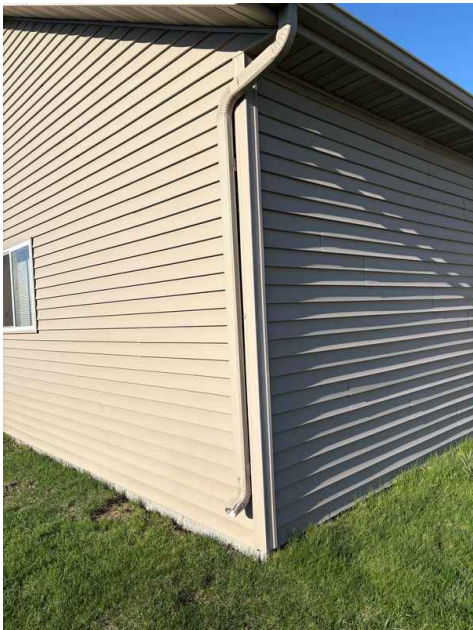
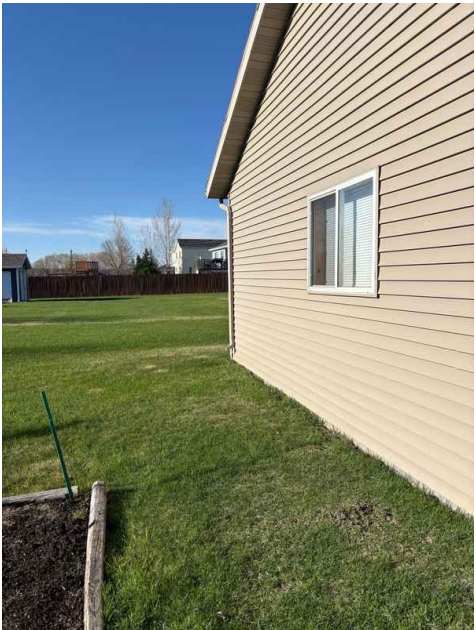
2.3.2 Roof Drainage Systems

DOWNSPOUTS MISSING

Home was missing downspouts in one or more areas. This can result in excessive moisture in the soil at the foundation, which can lead to foundation/structural movement. Recommend a qualified contractor install downspout extensions that drain at least 6 feet from the foundation.

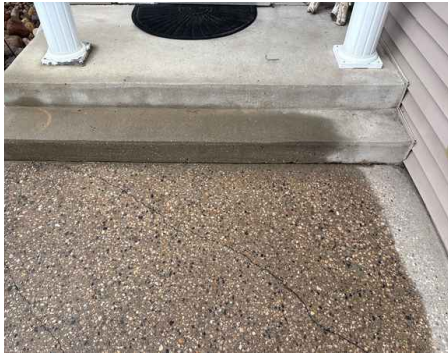
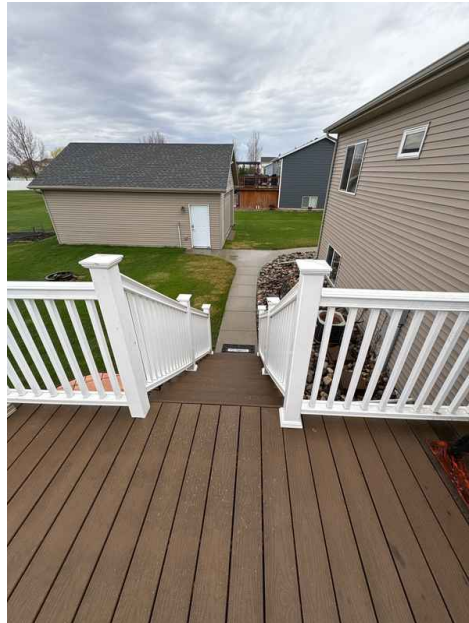
I inspected the stairs, steps, stoops, stairways and ramps that were within the scope of my home inspection.

All treads should be level and secure. Riser heights and tread depths should be as uniform as possible. As a guide, stairs must have a maximum riser of 7-3/4 inches and a minimum tread of 10 inches.

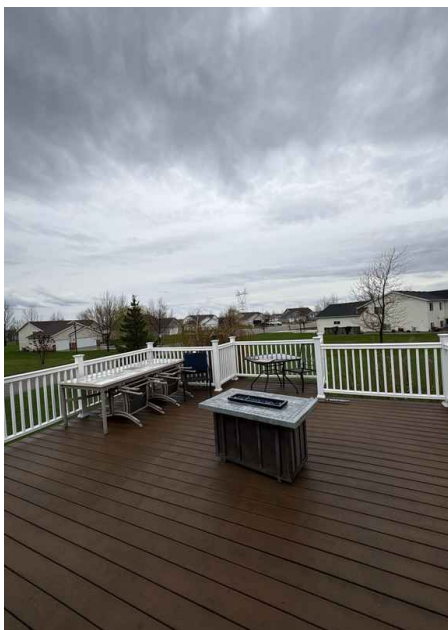
**Porches, Patios, Decks, Balconies & Carports: Porches, Patios, Decks, Balconies & Carports Were Inspected**

I inspected the porches, patios, decks, balconies and carports at the house that were within the scope of the home inspection.

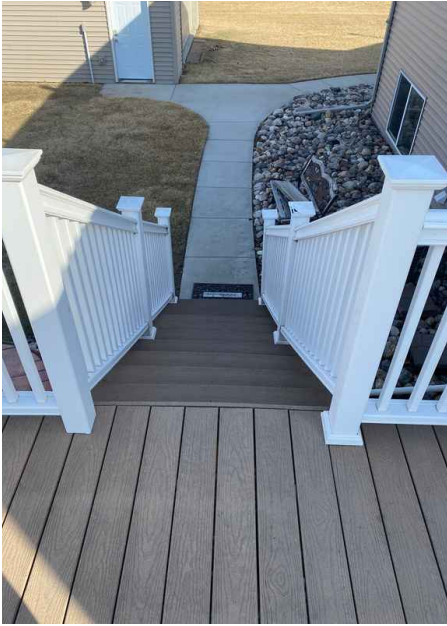
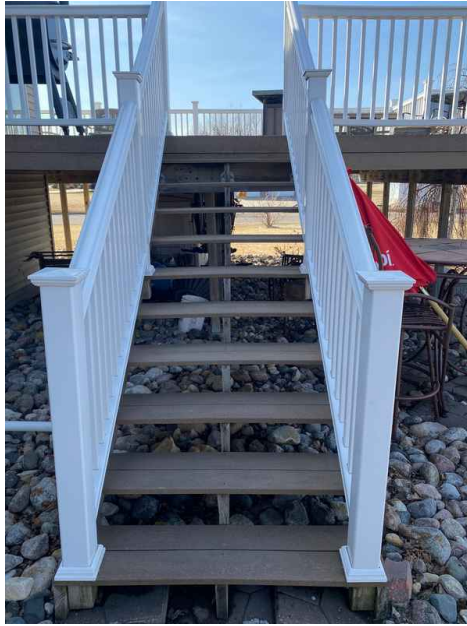
Railings, Guards & Handrails: Railings, Guards & Handrails Were Inspected

I inspected the railings, guards and handrails that were within the scope of the home inspection.

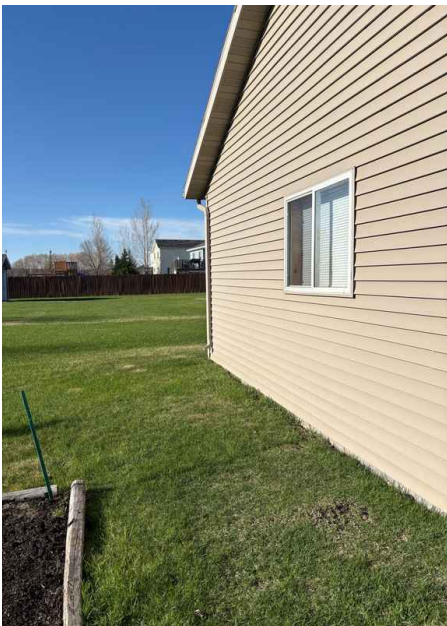
**Windows: Windows Inspected**

A representative number of windows from the ground surface was inspected.

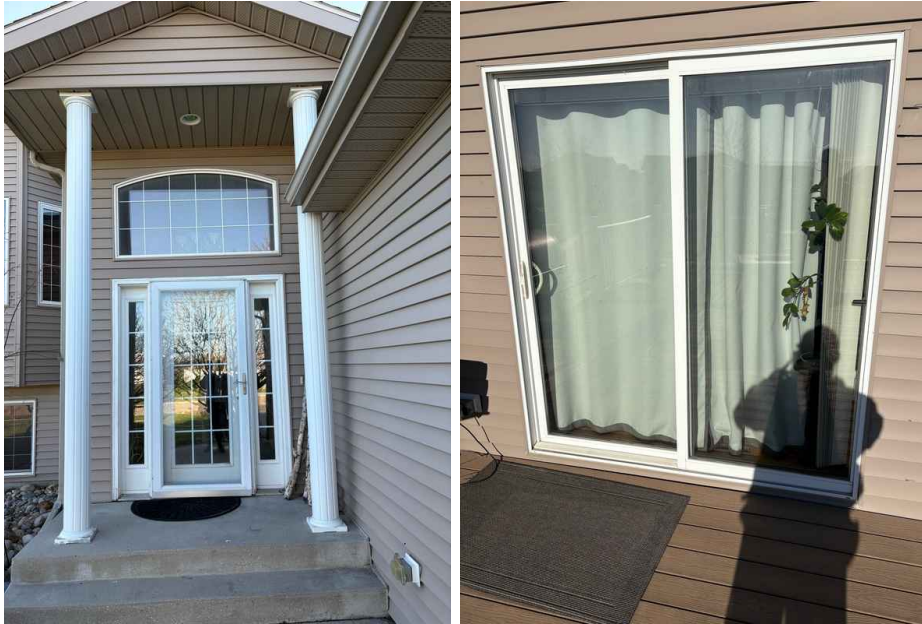
Exterior Doors: Exterior Doors Inspected

I inspected the exterior doors.

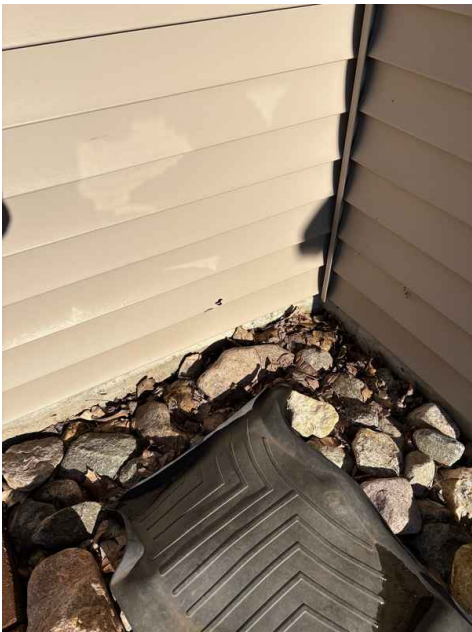
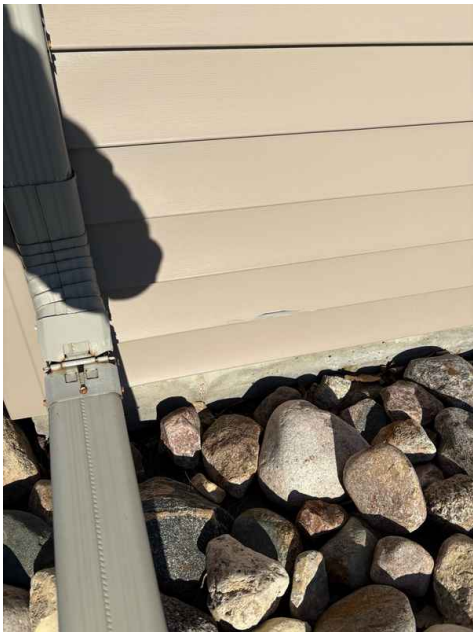
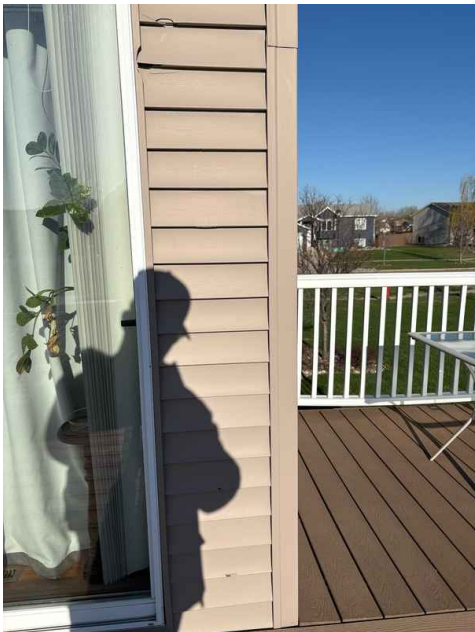
DAMAGED WALL-COVERING MATERIAL

Major Defect

There were multiple indications of cracking and chips missing out of the vinyl siding. Correction and further evaluation is recommended.

Recommendation
Contact a qualified siding specialist.

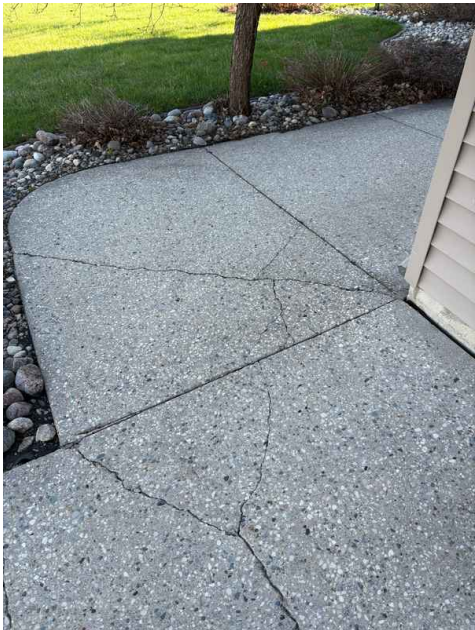
3.6.1 Walkways & Driveways

MINOR CRACKING AT WALKWAY

Minor Defect

I observed minor cracking and no major damage at the walkway. Monitoring is recommended.

Recommendation
Contact a handyman or DIY project

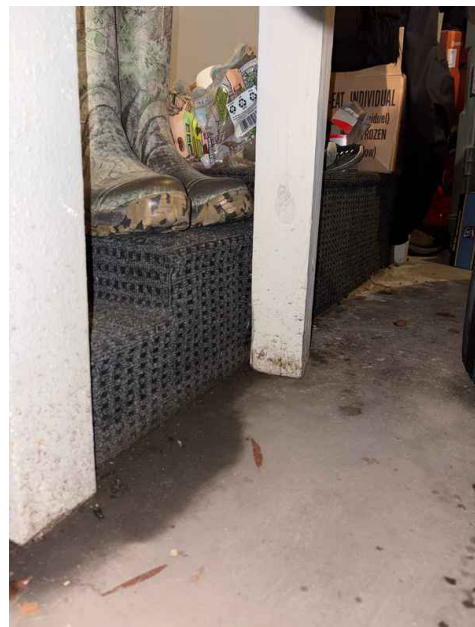
3.7.1 Stairs, Steps, Stoops, Stairways & Ramps

TREAD DEPTH TOO SHORT (SMALLER THAN 10")

Major Defect

I observed a defect at the stair riser depth. It's too short.

The minimum tread depth is 10 inches, measured between the projected nosings of adjacent treads. This poses a trip hazard.

Recommendation

Contact a qualified professional.

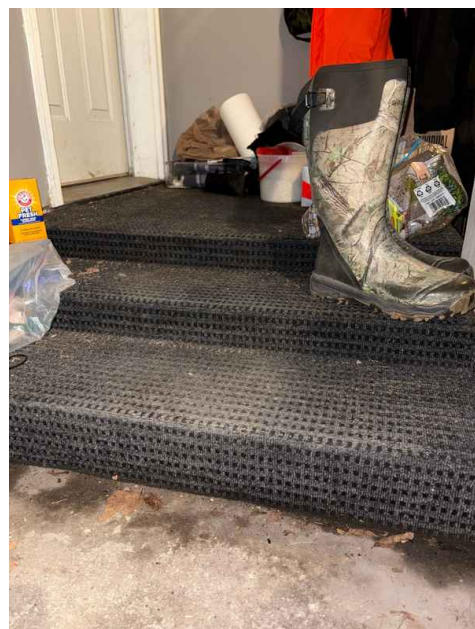
3.7.2 Stairs, Steps, Stoops, Stairways & Ramps

BIG DIFFERENCES BETWEEN TREADS (3/8")

Major Defect

I observed that there's a difference between the stair treads from one to another that is greater than 3/8 of an inch.

This poses as a trip hazard. The difference between one step and other is at most 3/8 of an inch.

Recommendation

Contact a qualified professional.

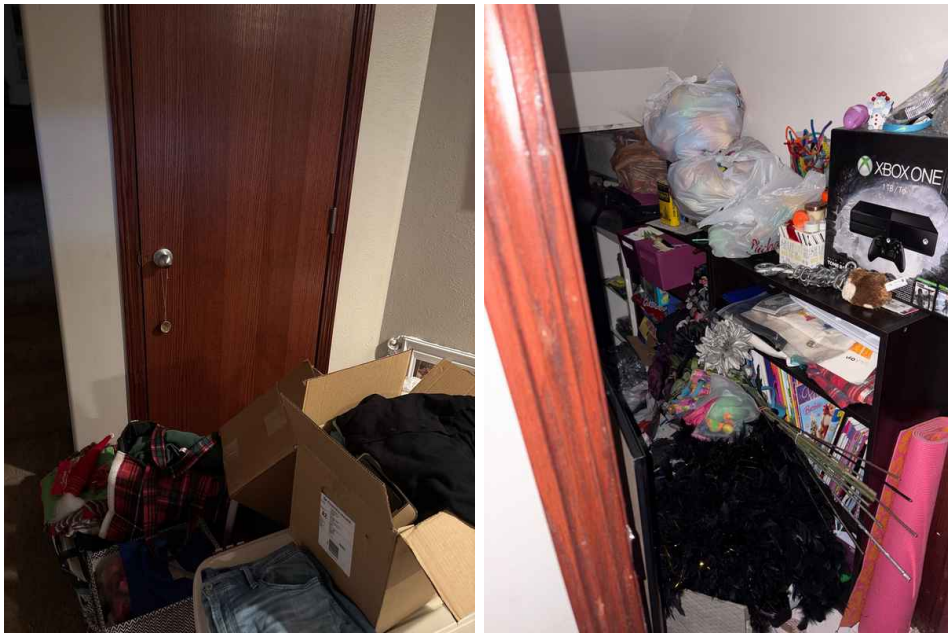
TOTALLY INACCESSIBLE

The crawlspace was inaccessible. This is an inspection restriction. I don't know what's going on inside the crawlspace, because I could not enter it. Access needs to be provided in order to inspect and evaluate the crawlspace condition.

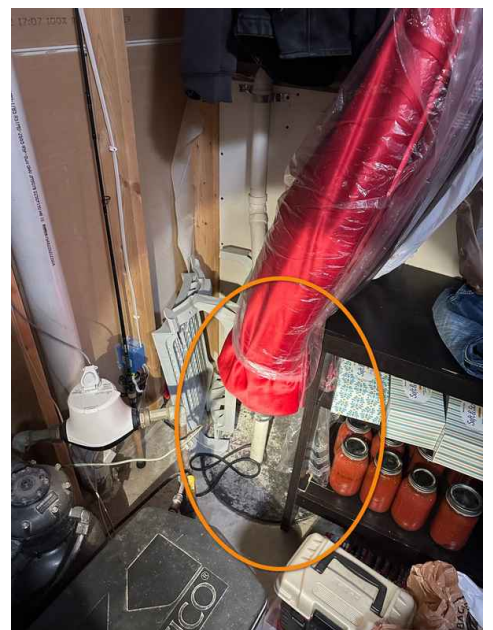
Major Defect

I observed that the sump pump was obstructed by shelving in the utility room. A sump pump should be accessible for easy access in case of an emergency.

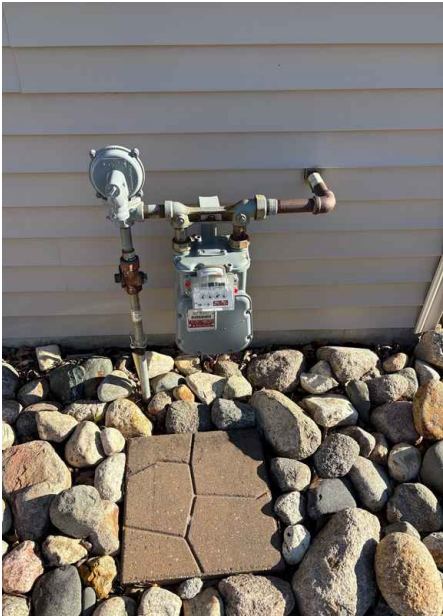
Heating System Information: Energy Source

Gas

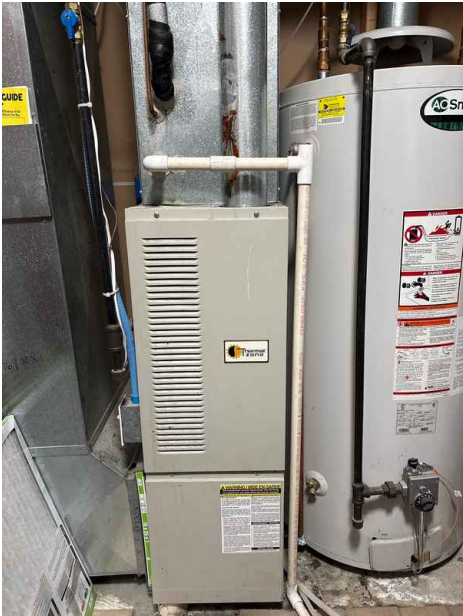
Heating System Information: Heating Method

Warm-Air Heating System

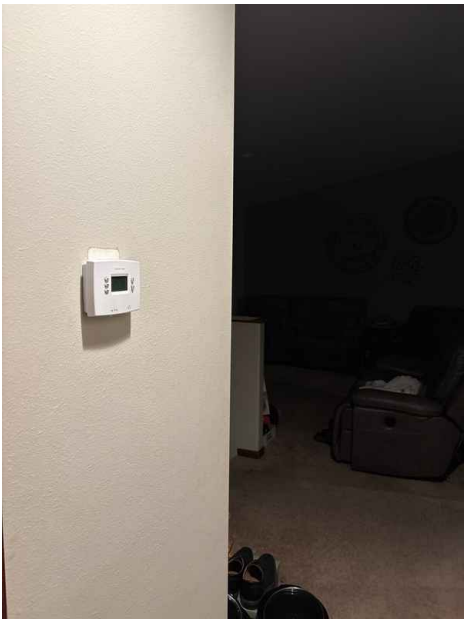
Thermostat and Normal Operating Controls: Thermostat Location

Living room, First floor

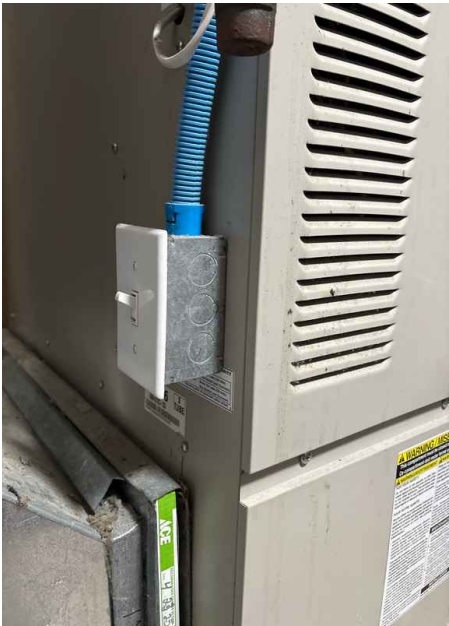
Thermostat and Normal Operating Controls: Emergency Shut-Off Switch Inspected

I observed an emergency shut-off switch. I inspected it. It worked when I used it during my inspection.

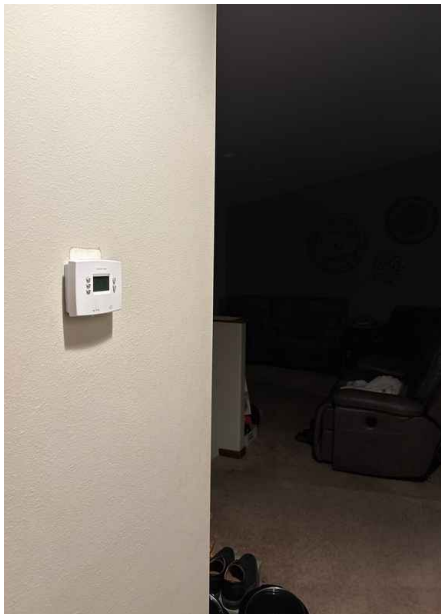
Operating Controls: Thermostat Location

First floor, Living room

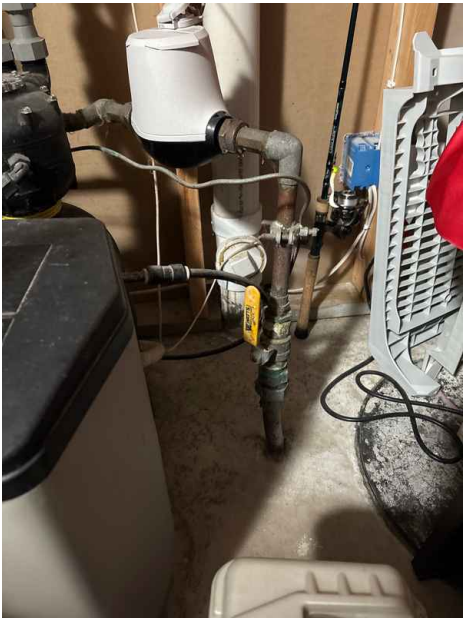
Main Water Shut-Off Valve:
Location of Main Shut-Off Valve

Basement

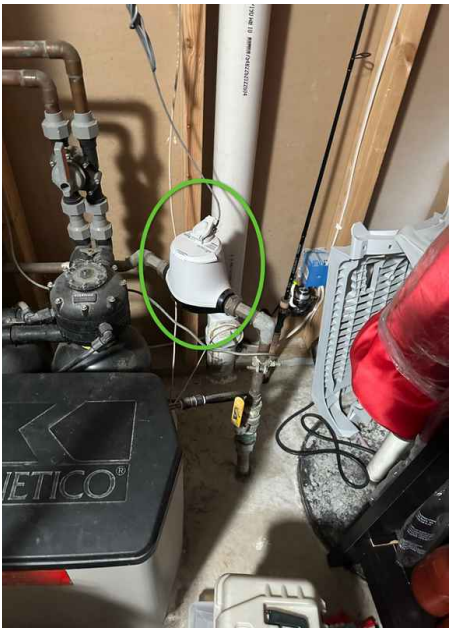
Water Supply : Water Supply Is Public

The water supply to the house appeared to be from the public water supply source based upon the observed indications at the time of the inspection. To confirm and be certain, I recommend asking the homeowner for details.

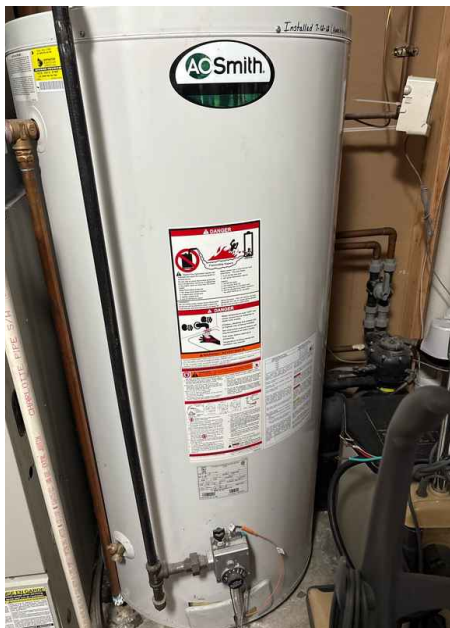
Hot Water Source: Type of Hot Water Source

Gas-Fired Hot Water Tank

I inspected for the main source of the distributed hot water to the plumbing fixtures (sinks, tubs, showers). I recommend asking the homeowner for details about the hot water equipment and past performance.

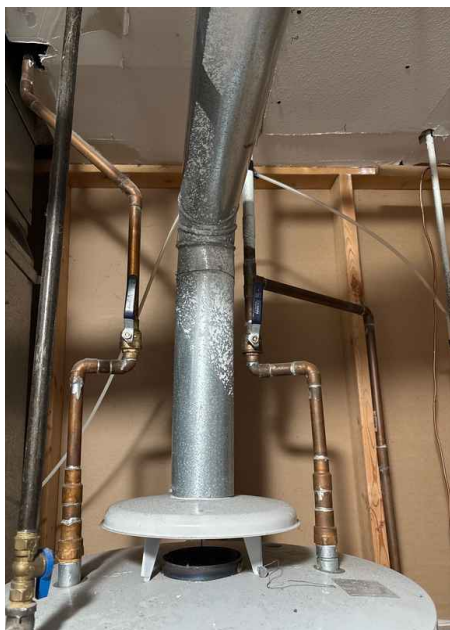
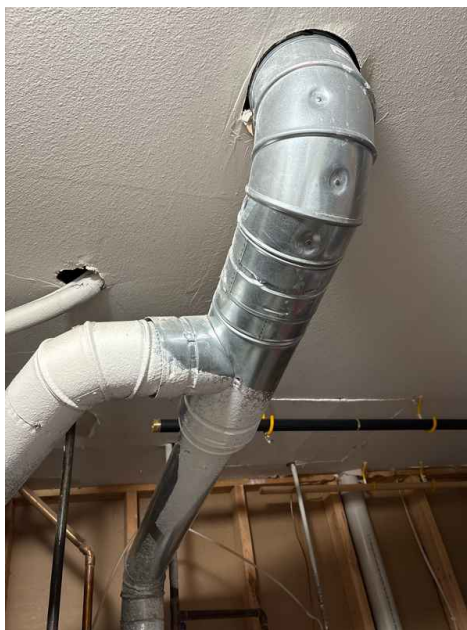
Hot Water Source: Inspected Venting Connections

I inspected the venting connections.

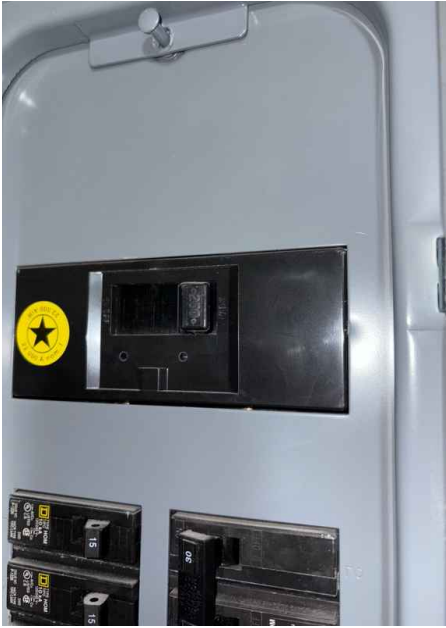
200

I observed indications of the main service disconnect's amperage rating. It was labeled.

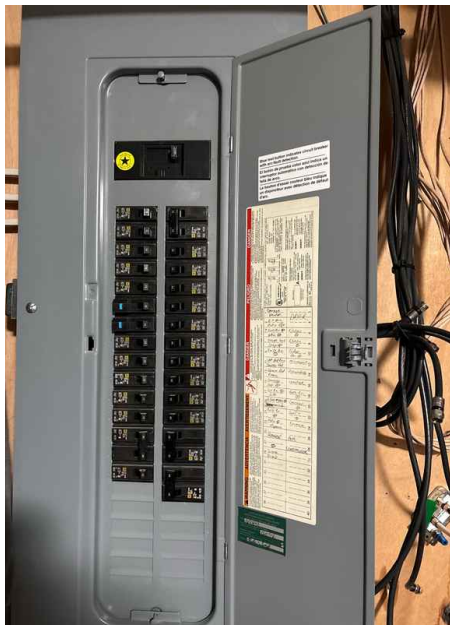
Panelboards & Breakers: Inspected Main Panelboard & Breakers

I inspected the electrical panelboards and over-current protection devices (circuit breakers and fuses).

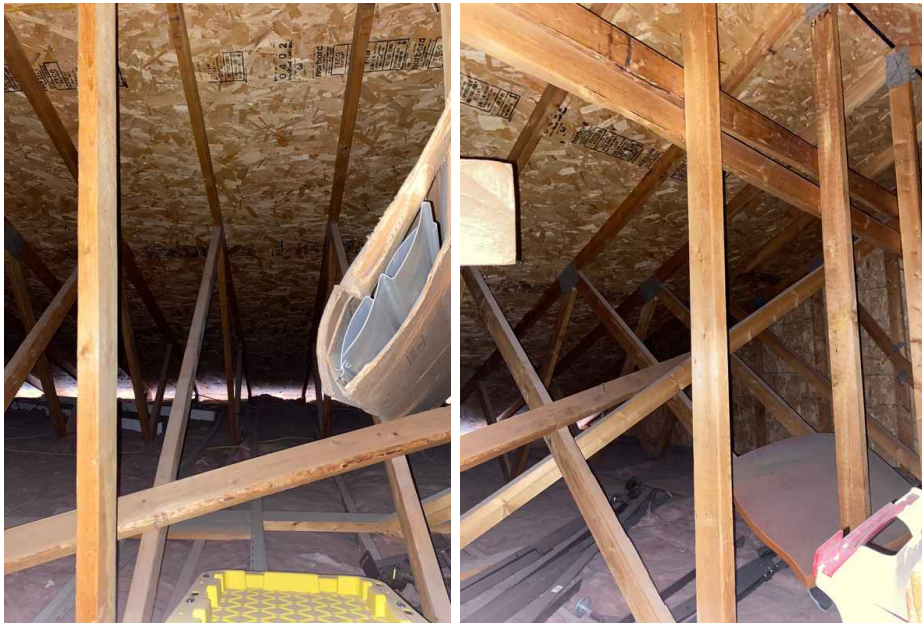
I attempted to describe the type of insulation observed and the approximate average depth of insulation observed at the unfinished attic floor area or roof structure.

I reported as in need of correction the general absence of insulation or ventilation in unfinished spaces.

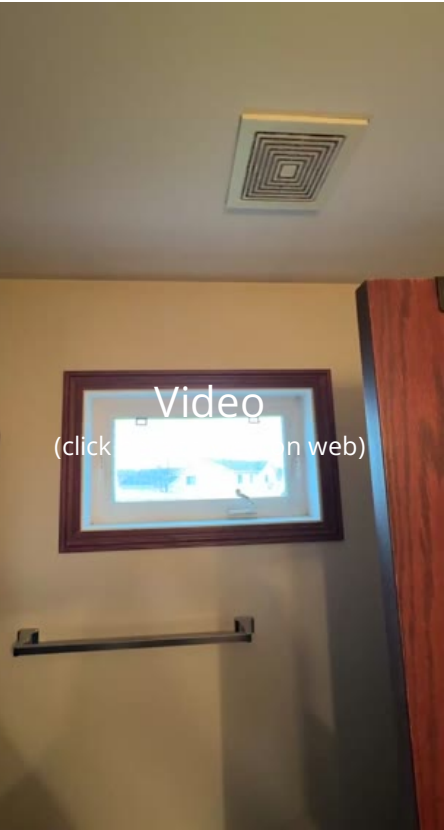
Bathroom Exhaust Fan / Window: Inspected Bath Exhaust Fans

I inspected the exhaust fans of the bathroom(s). All mechanical exhaust fans should terminate outside. Confirming that the fan exhausts outside is beyond the scope of a home inspection.

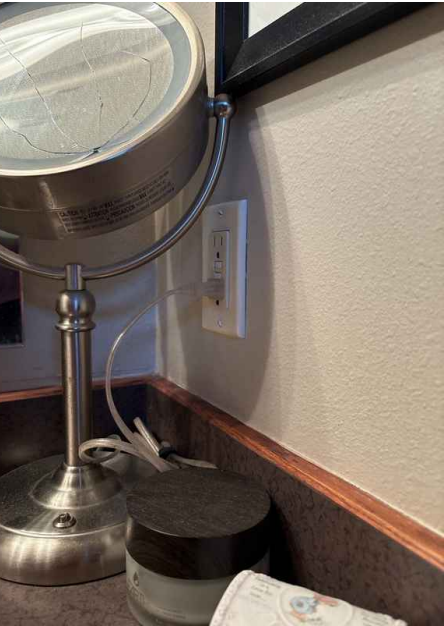
GFCI & Electric in Bathroom: GFCI-Protection Tested

I inspected the GFCI-protection at the receptacle near the bathroom sink by pushing the test button at the GFCI device or using a GFCI testing instrument.

All receptacles in the bathroom must be GFCI protected.

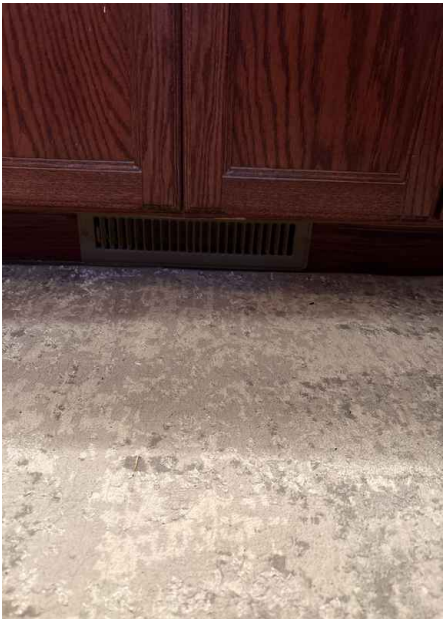
Heat Source in Bathroom: Heat Source in Bathroom Was Inspected

I inspected the heat source in the bathroom (register/baseboard).

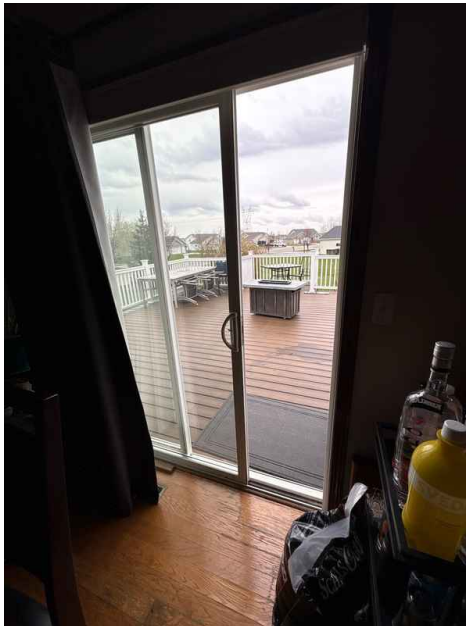
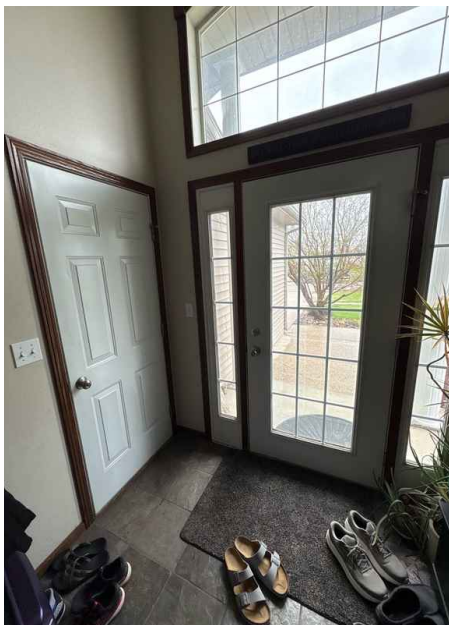
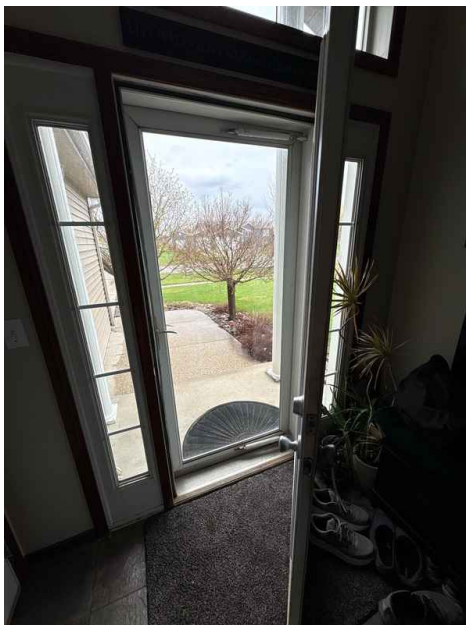
Doors: Doors Inspected

I inspected a representative number of doors according to the [Home Inspection Standards of Practice](#) by opening and closing them. I did not operate door locks and door stops, which is beyond the scope of a home inspection.

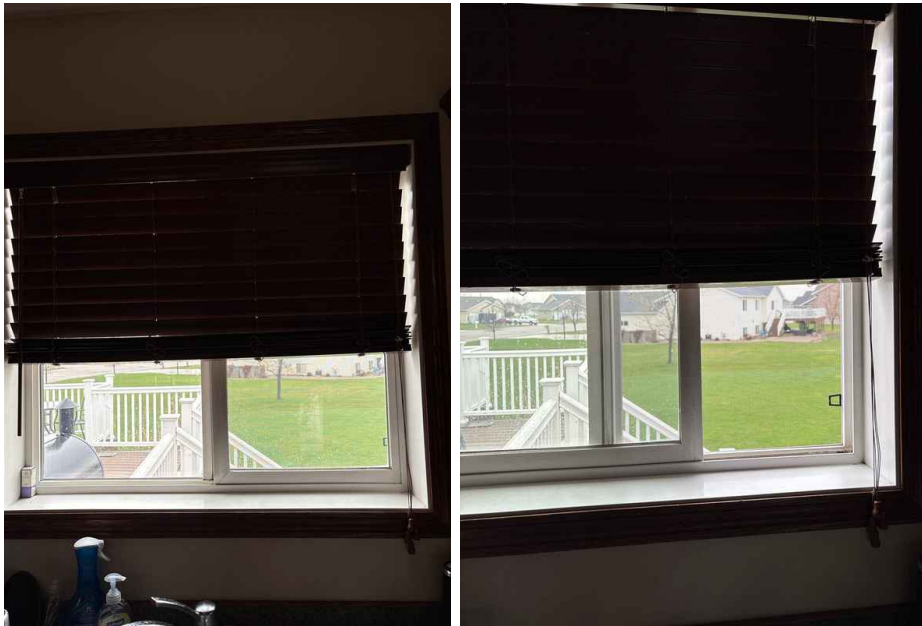
Windows: Windows Inspected

I inspected a representative number of windows according to the [Home Inspection Standards of Practice](#) by opening and closing them. I did not operate window locks and operation features, which is beyond the scope of a home inspection.

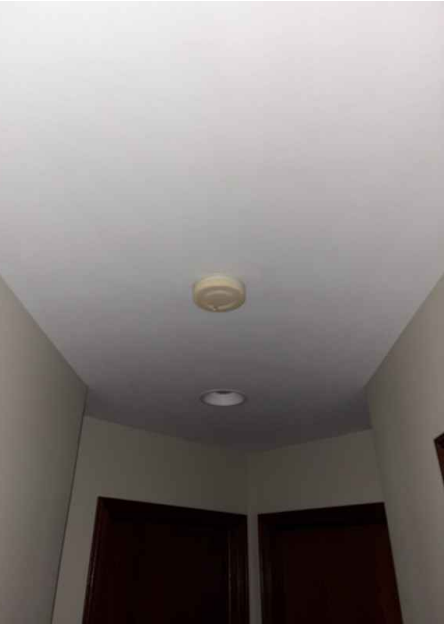
I inspected for the presence of smoke and carbon-monoxide detectors.

There should be a smoke detector in every sleeping room, outside of every sleeping room, and one every level of a house.

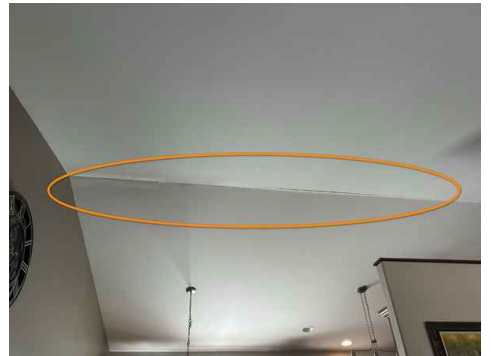
11.4.1 Floors, Walls, Ceilings

MINOR CORNER CRACKS

Recommendation

Contact a qualified professional.

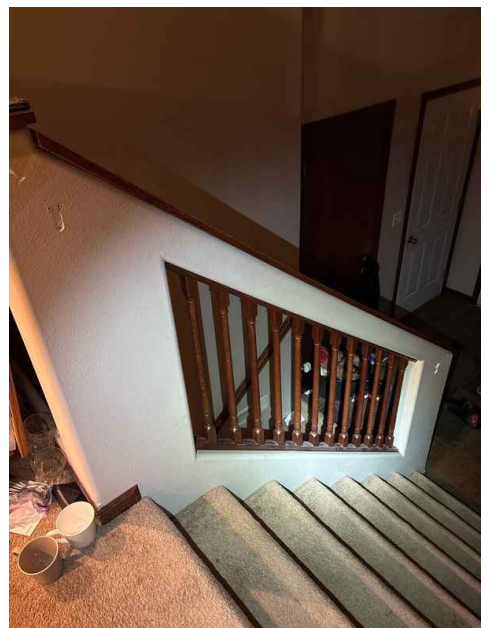
11.6.1 Railings, Guards & Handrails

MISSING HANDRAIL

Recommendation

Contact a qualified professional.

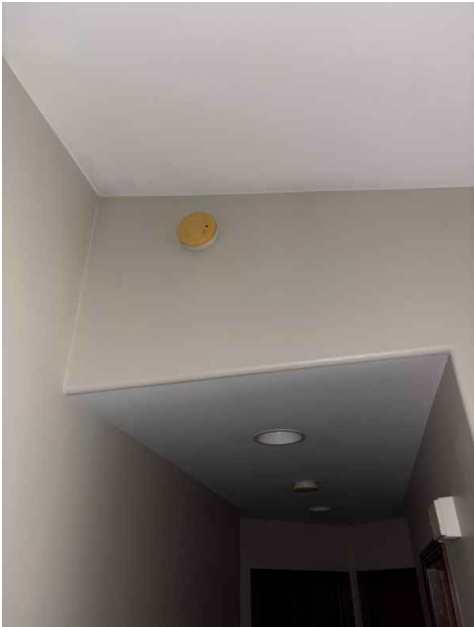
11.7.1 Presence of Smoke and CO Detectors

**OLD DETECTORS, NEW DETECTORS
RECOMMENDED**

Major Defect

Contact a qualified fire suppression contractor.

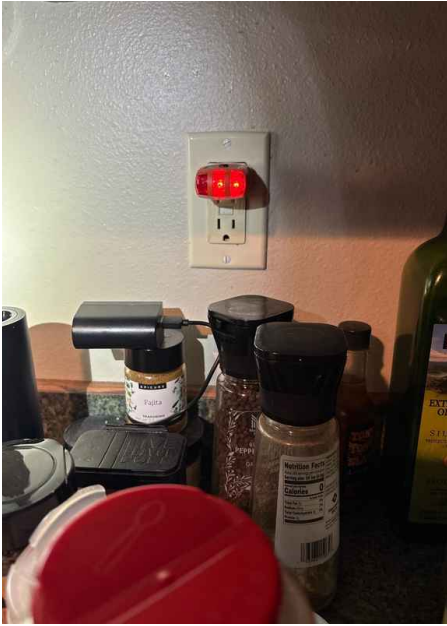
GFCI: GFCI Tested

I observed ground fault circuit interrupter (GFCI) protection in the kitchen.

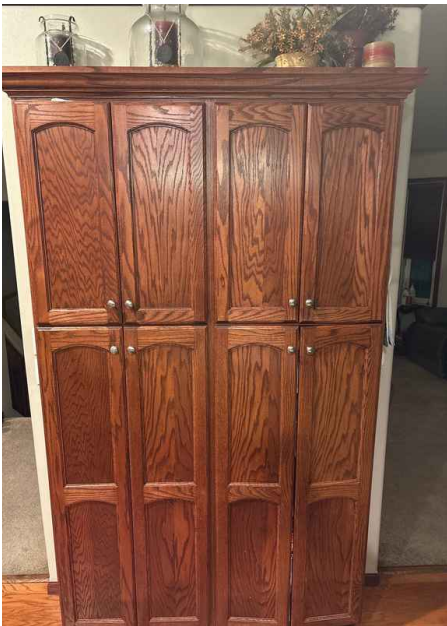
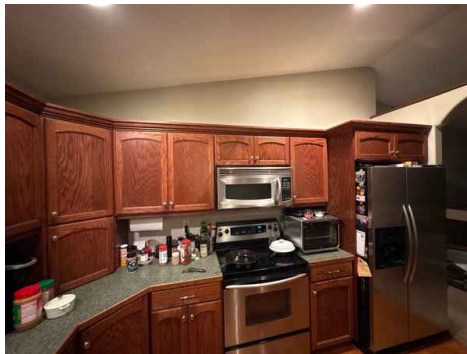
**Countertops & Cabinets: Inspected Cabinets & Countertops**

I inspected a representative number of cabinets and countertop surfaces.

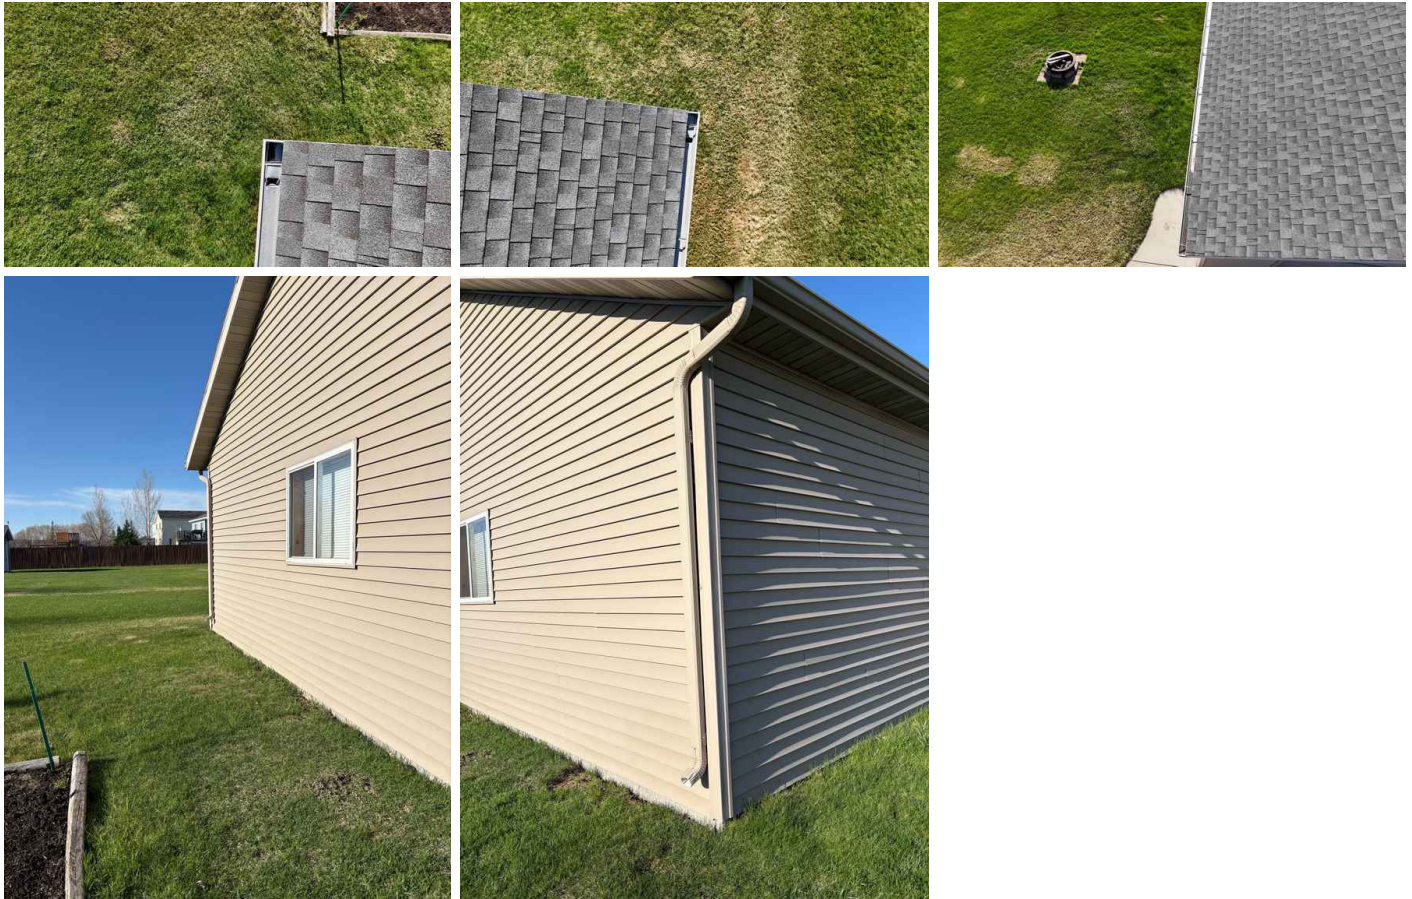
I inspected the gutters. I wasn't able to inspect every inch of every gutter. But I attempted to check the overall general condition of the gutters during the inspection and look for indications of major defects. Gutters were free of debris.

Monitoring the gutters during a heavy rain (without lightening) is recommended. In general, the gutters should catch rain water and direct the water towards downspouts that discharge the water away from the house foundation.

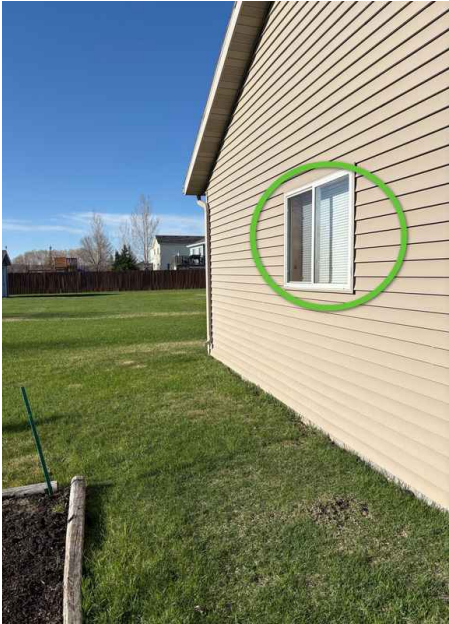
Windows: Windows Inspected

A representative number of windows from the ground surface was inspected at the detached garage.

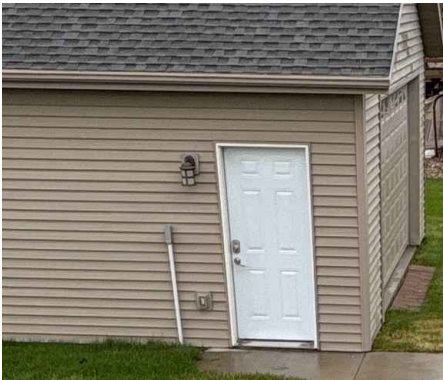
Exterior Door: Exterior Doors Inspected

I inspected the exterior doors of the detached garage.
